TITLE Aviation Turbine Engine Diagnostic System (ATEDS) for the OH-58D Helicopter

AUTHOR Larry R. DeMott

FINAL REPORT

**Development and SGML-Tagging
of
Troubleshooting and Diagnostic
Procedures
for
Rolls-Royce Allison
T703-AD-700 and 250-C30R/3 Engines,
and 250-C30R/3 FADEC**

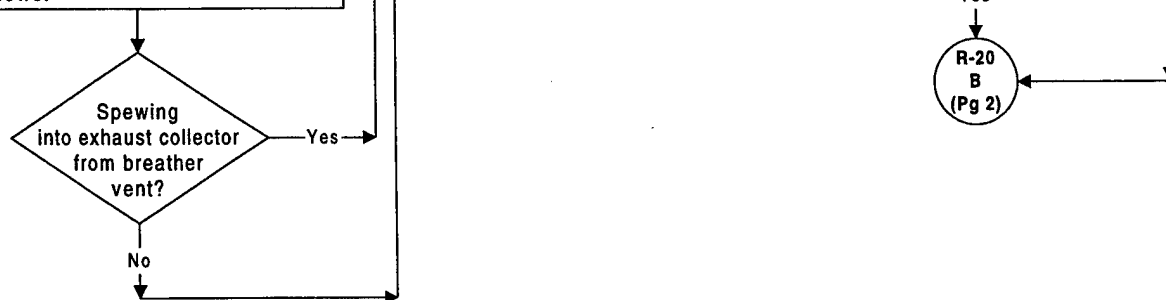
R-20. Oil Spewing Or Seeping From Gearbox Vent And Tubing Joints

Spewing into the exhaust stream can result from leakage of the lip seal on the centrifugal breather gearshaft, which bypasses the gear and does not benefit from the separating action. Another source is excessive air leakage into the gearbox, from too high compressor seal vent pressure or from worn or damaged turbine seals in cooling air or pressure balance circuits.

If oil spewing or seeping from the accessory gearbox breather vent or tubing joints is encountered, proceed as follows:

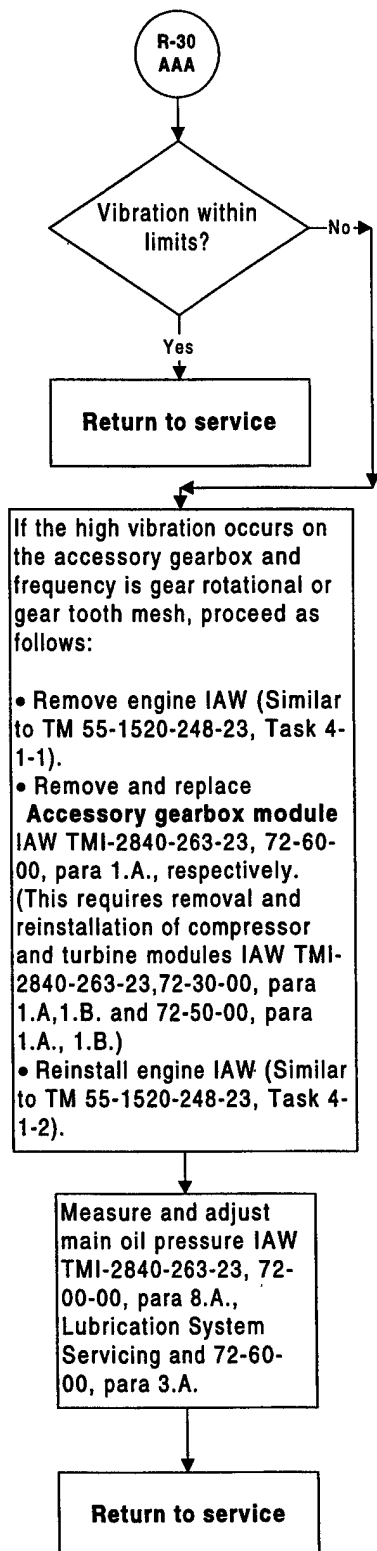
R-30. Excessive Vibration

- Loose engine mounts
- Accessory unbalance
- Engine rotor system unbalance (gas generator or power turbine)
- Gear tooth mesh
- Gear unbalance
- Bearing failure
- Response to aircraft rotor system, or to drive system unbalance or alignment

The presence of vibration is sometimes difficult to detect by touch or sound (depending upon frequency and amplitude) but it makes itself known by unusual wear and fretting of external parts and equipment, loosening of nuts, bolts, fasteners, and fittings, etc.
